INSPECTION AND CORRECTION OF BELLHOUSING TO CRANKSHAFT ALIGNMENT

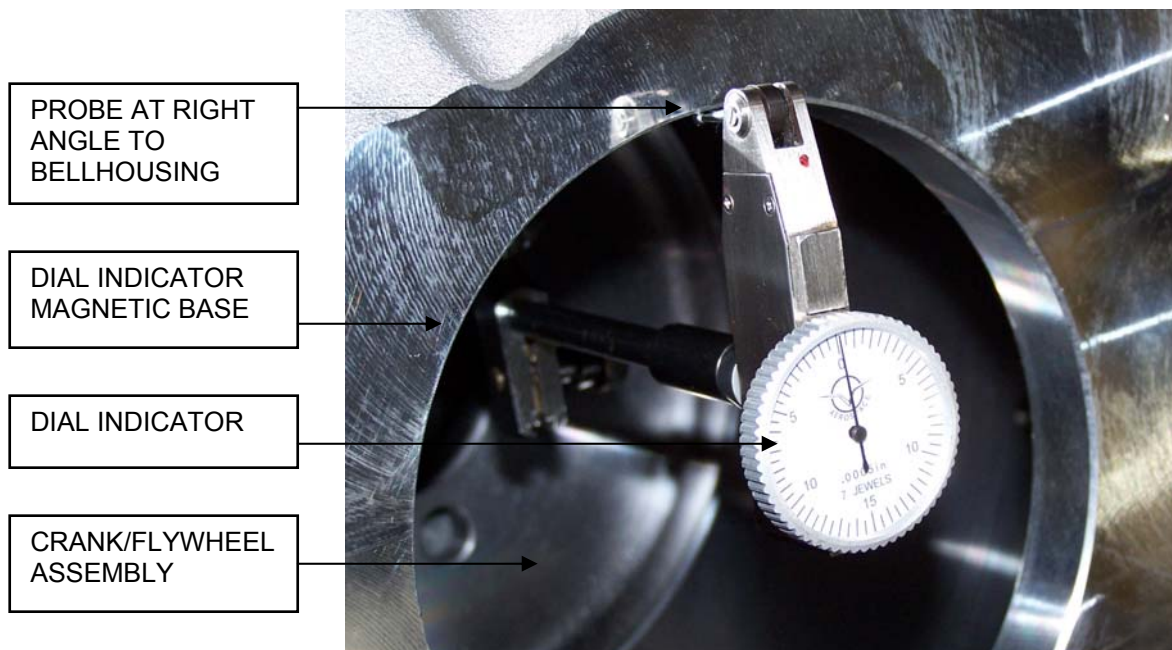
3. Position the indicator probe in contact with the smooth bore of the bellhousing that the transmission will fit into later. The **dial indicator probe** needs to be **perpendicular** to the bellhousing face to ensure accuracy.

Make sure the indicator has adequate travel in both directions and will be in constant contact with the bore register during the entire 360 degrees of rotation so that you will obtain accurate readings. It is not necessary to begin at a certain position on the bore, any point will work. Mark the point where you begin on the bellhousing with a hash mark using chalk or a marker as a reference.

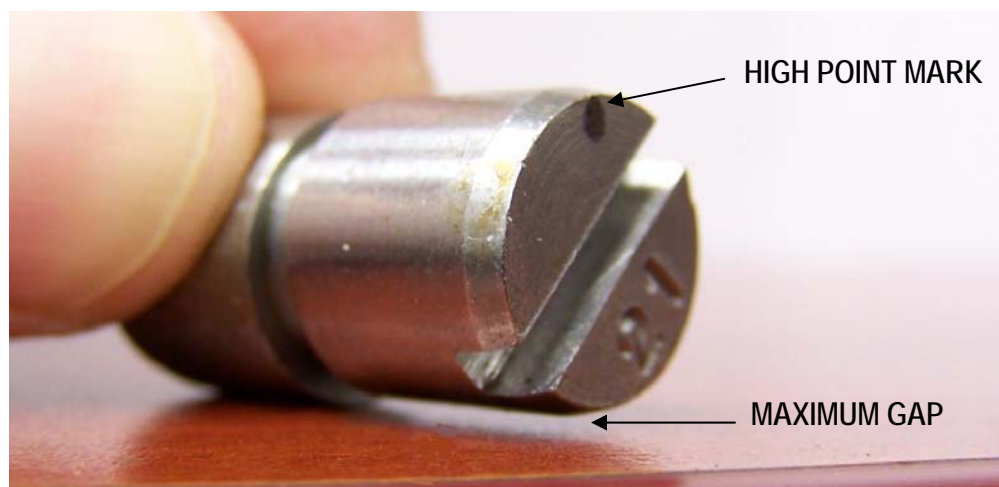
- f. Heat may help.
3. Determine where the maximum offset is on each new pin by rolling the engine side of the dowel on a hard flat surface and looking for the maximum height point as it is being rolled. Mark the high spot with a dot from a paint marker or permanent marker.

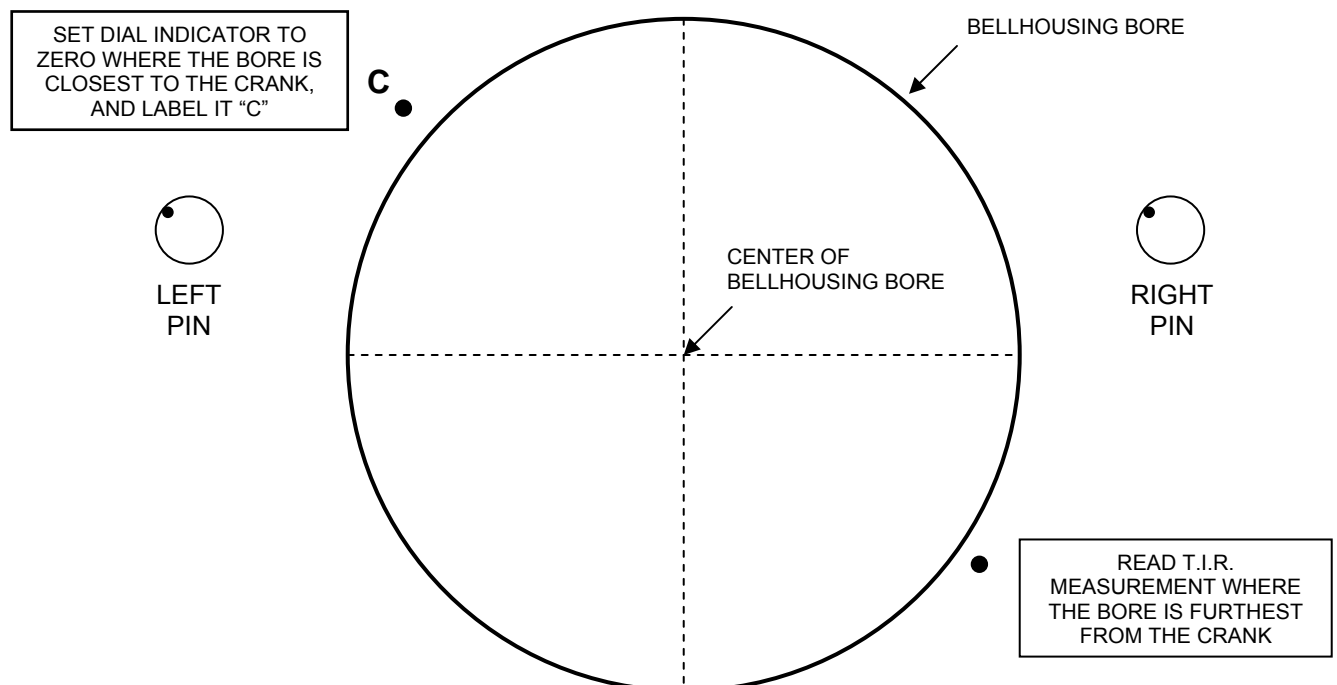
On the bellhousing below, the misalignment is such that the bore is closest to the crank at the upper left. The dial indicator would be set to zero at that point (labeled "C"). The T.I.R. would be measured where the bellhousing bore is furthest from the crank, which should be directly opposite that point. Let's assume the T.I.R. reading is 0.034". Actual misalignment would then be:

$$0.034" \div 2 = 0.017"$$

The chart on page three shows that 0.017" misalignment requires a pair of 0.014" offset pins. The pins should be oriented so that their maximum offset is in the same direction as an imaginary line drawn from bore center to point "C".

5. Install the pins into the rear of your engine block with the dot on the pins (maximum offset point) oriented in the same direction as the "C" mark on the bellhousing bore. **Always orient both pins in the same direction!**
